MEMORANDUM

RE: Studies conducted on Armor Coat PPC911 Coating

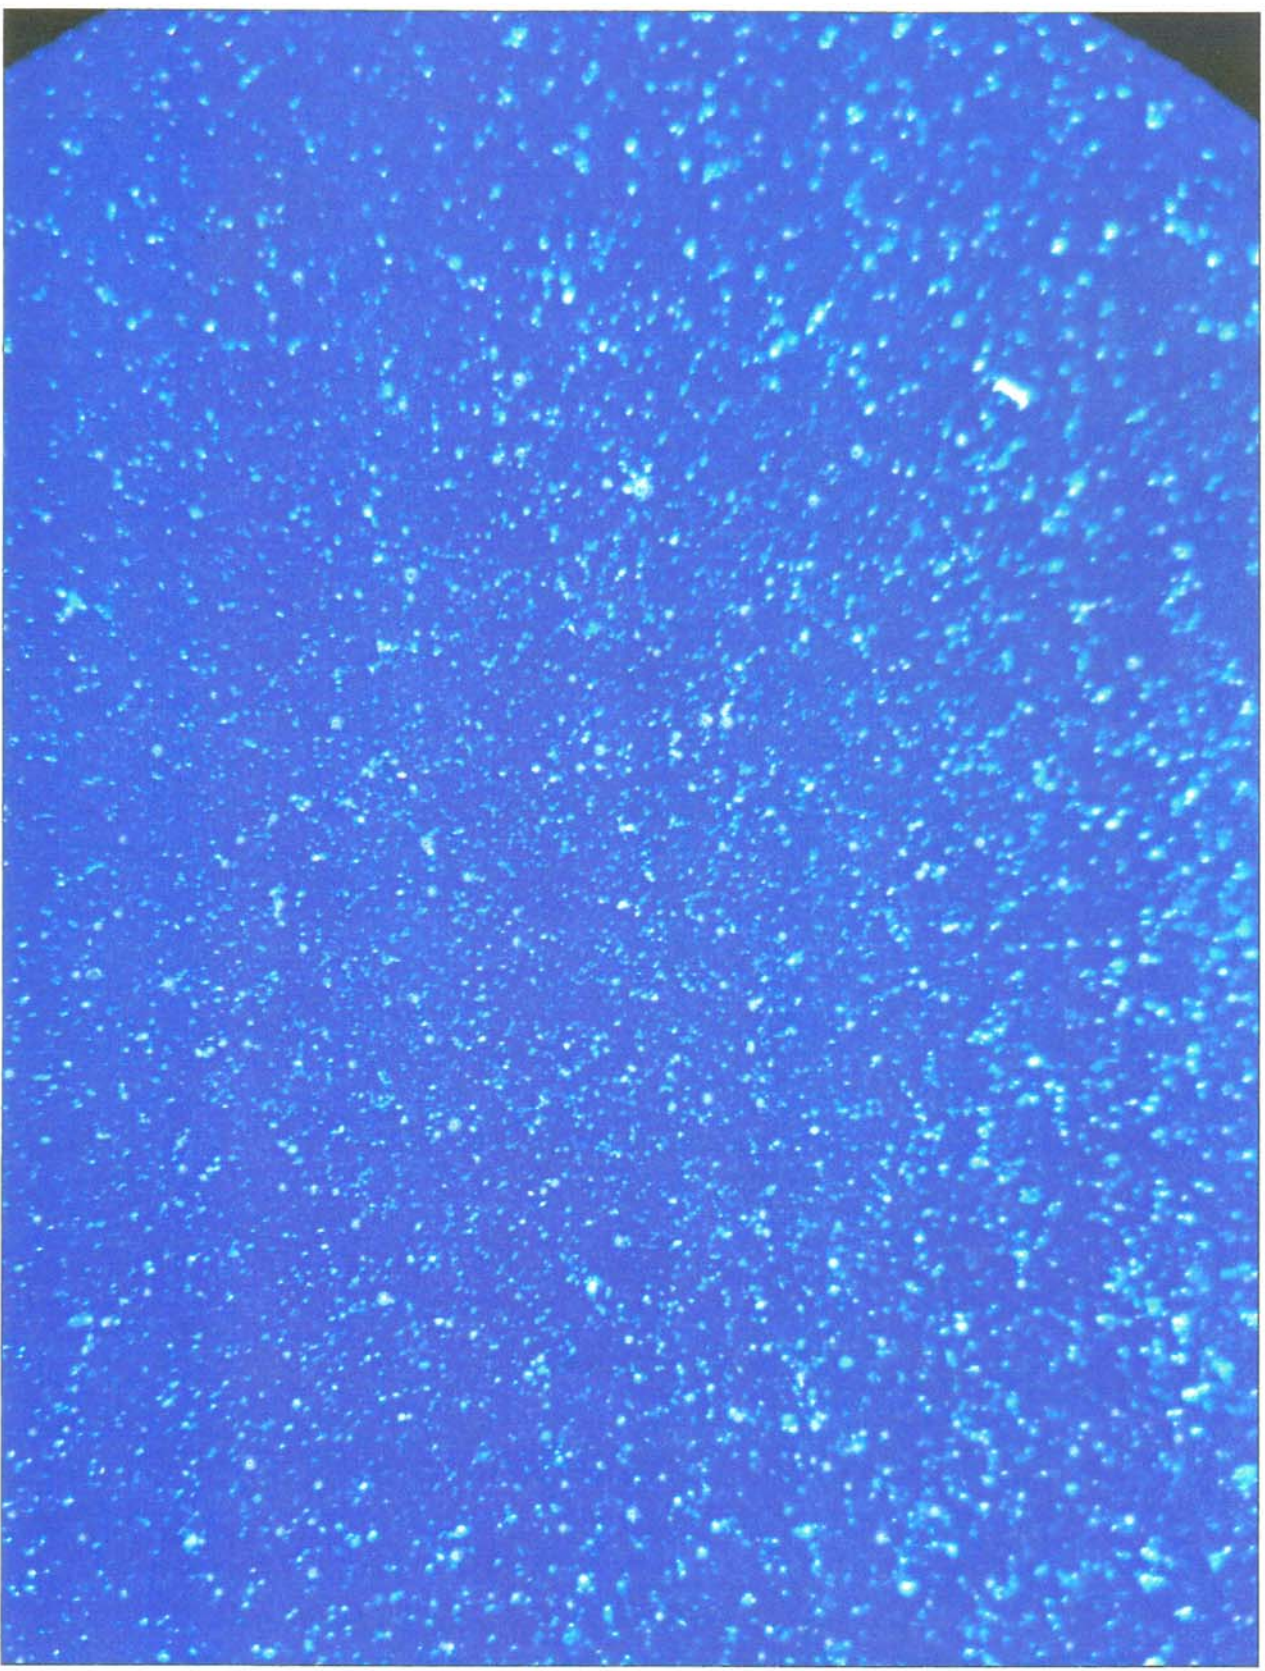
G4 at 1.0X

The first tests that were conducted consisted of a microscopic examination of the test panel that you sent to me that was coated with the Armor Coat product. The micrographs that were taken are presented in Appendix A. The three micrographs are listed as G4, G5, G6, and are taken at different magnifications, with the magnification listed on the micrograph. The white spots that you see in each of the micrographs correspond to opaque pieces of the polymer that are embedded in the polymer film. Upon high magnification such as in G6, holes can be seen in the surface of the polymer film. These holes are all approximately 45 micrometers in diameter. From the sample that you sent to me it was not possible to determine if the opaque pieces of polymer and holes in the surface were caused by your spraying procedure or is characteristic of the way that this polymer cures.

(35.5X) ArmorCoat Sample as Received

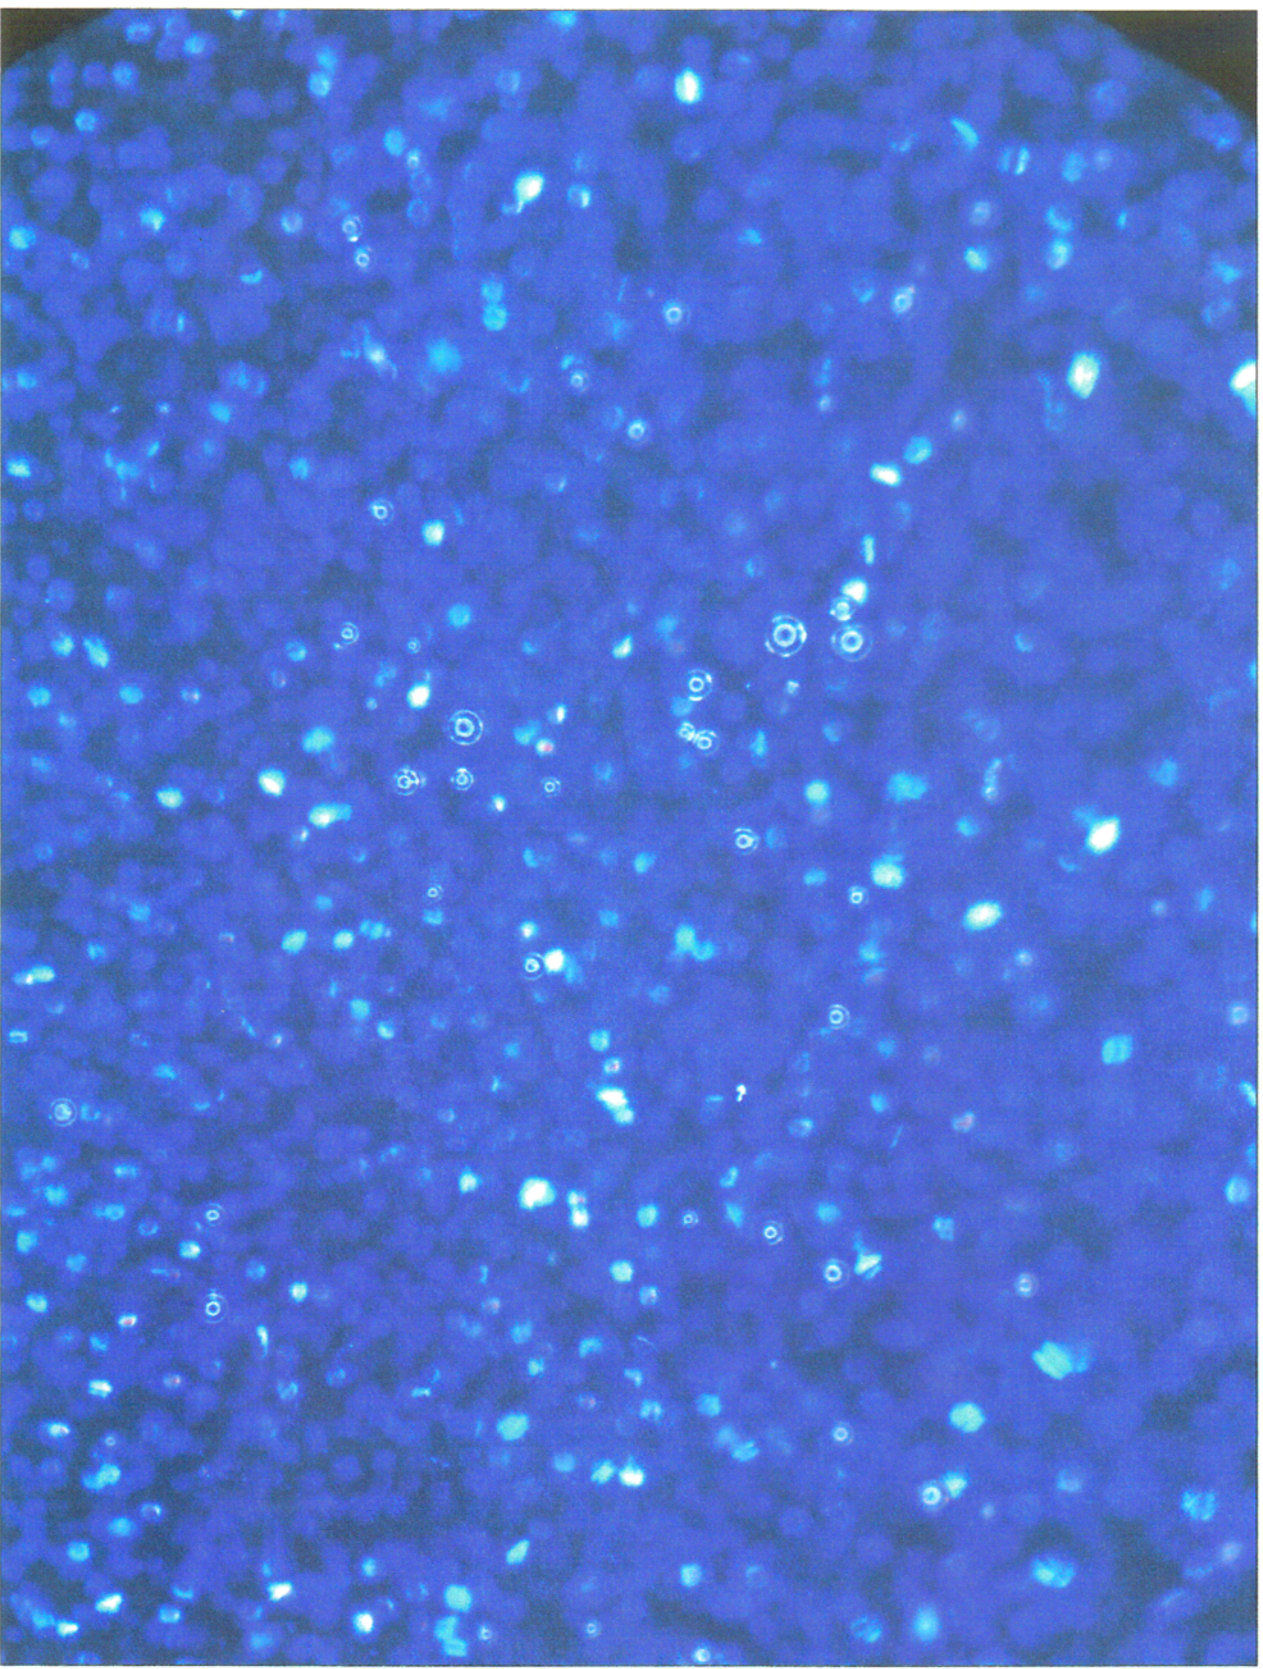
G5 at 3.0X

(106X) ArmorCost Sample as Received

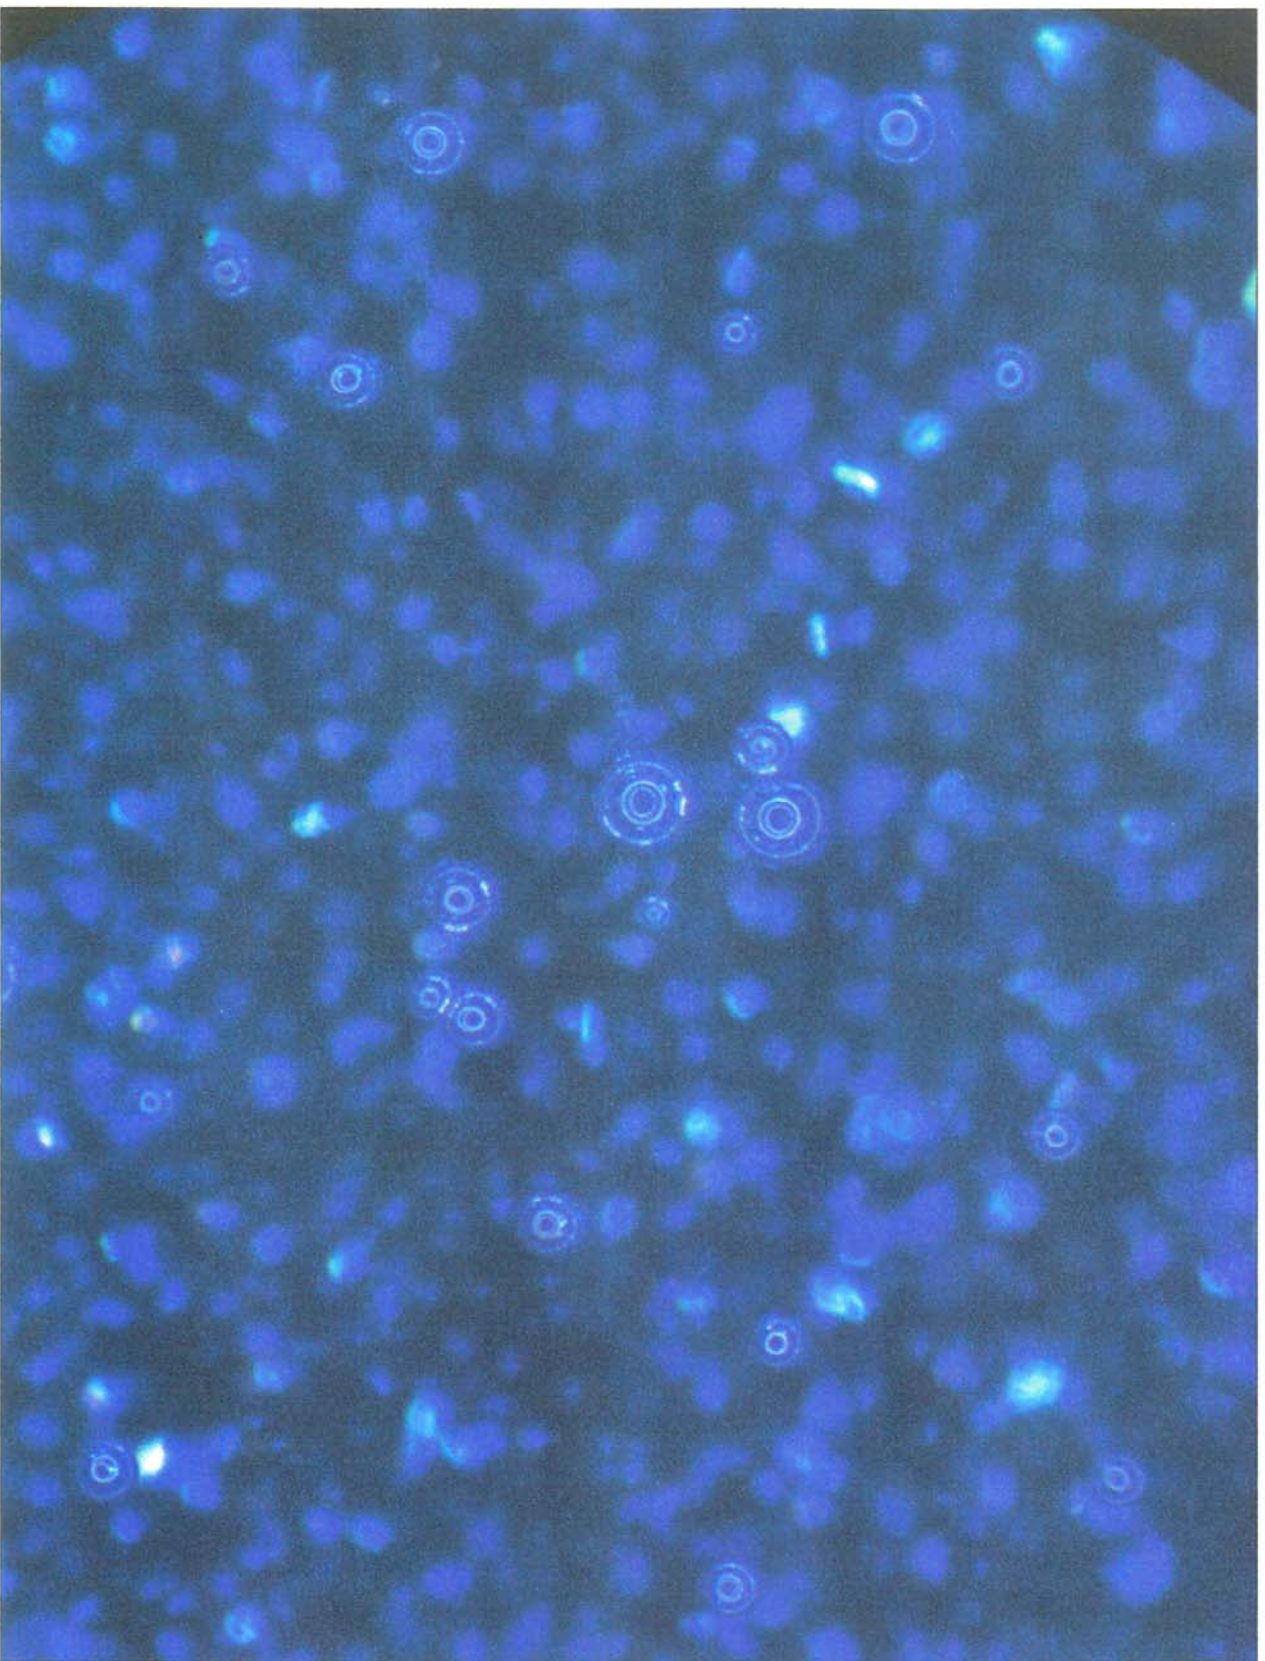
G6 at 6.3X

(224X) ArmorCoat Sample 23 Received

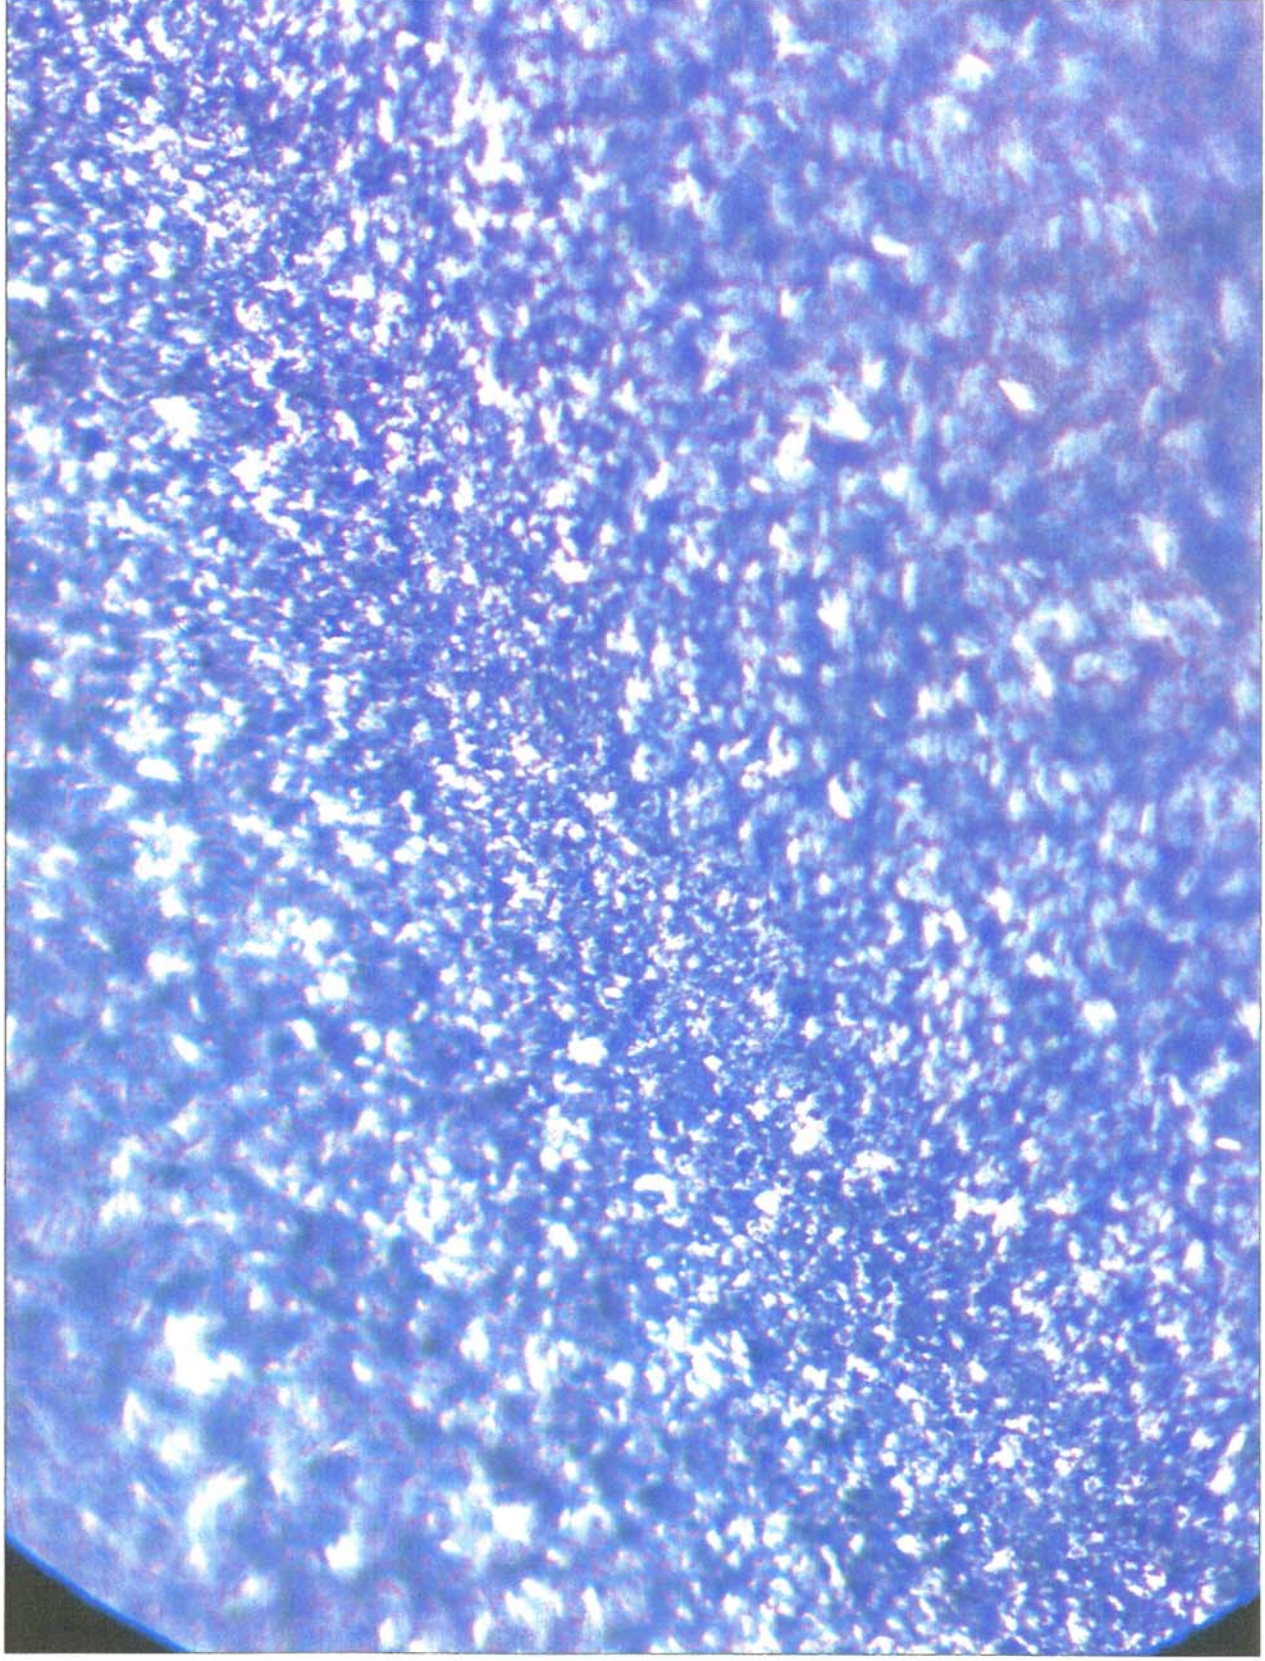
S1 at 6.3X

Micrographs of the GM vehicles are labeled as S1, S2 and S3. The Chrysler vehicle is labeled as Y1 and Y2 as shown in Appendix B. What you see in these surfaces is a clear coating with the painted surface underlying the clear coat. There are no holes in the surface and no pieces of opaque polymer in the polymer coat. It should be noted that the clear coat thickness for the GM and Chrysler finishes was approximately 3 mils, whereas the Armor Coat finish was approximately 8 mils thick.

GM finish

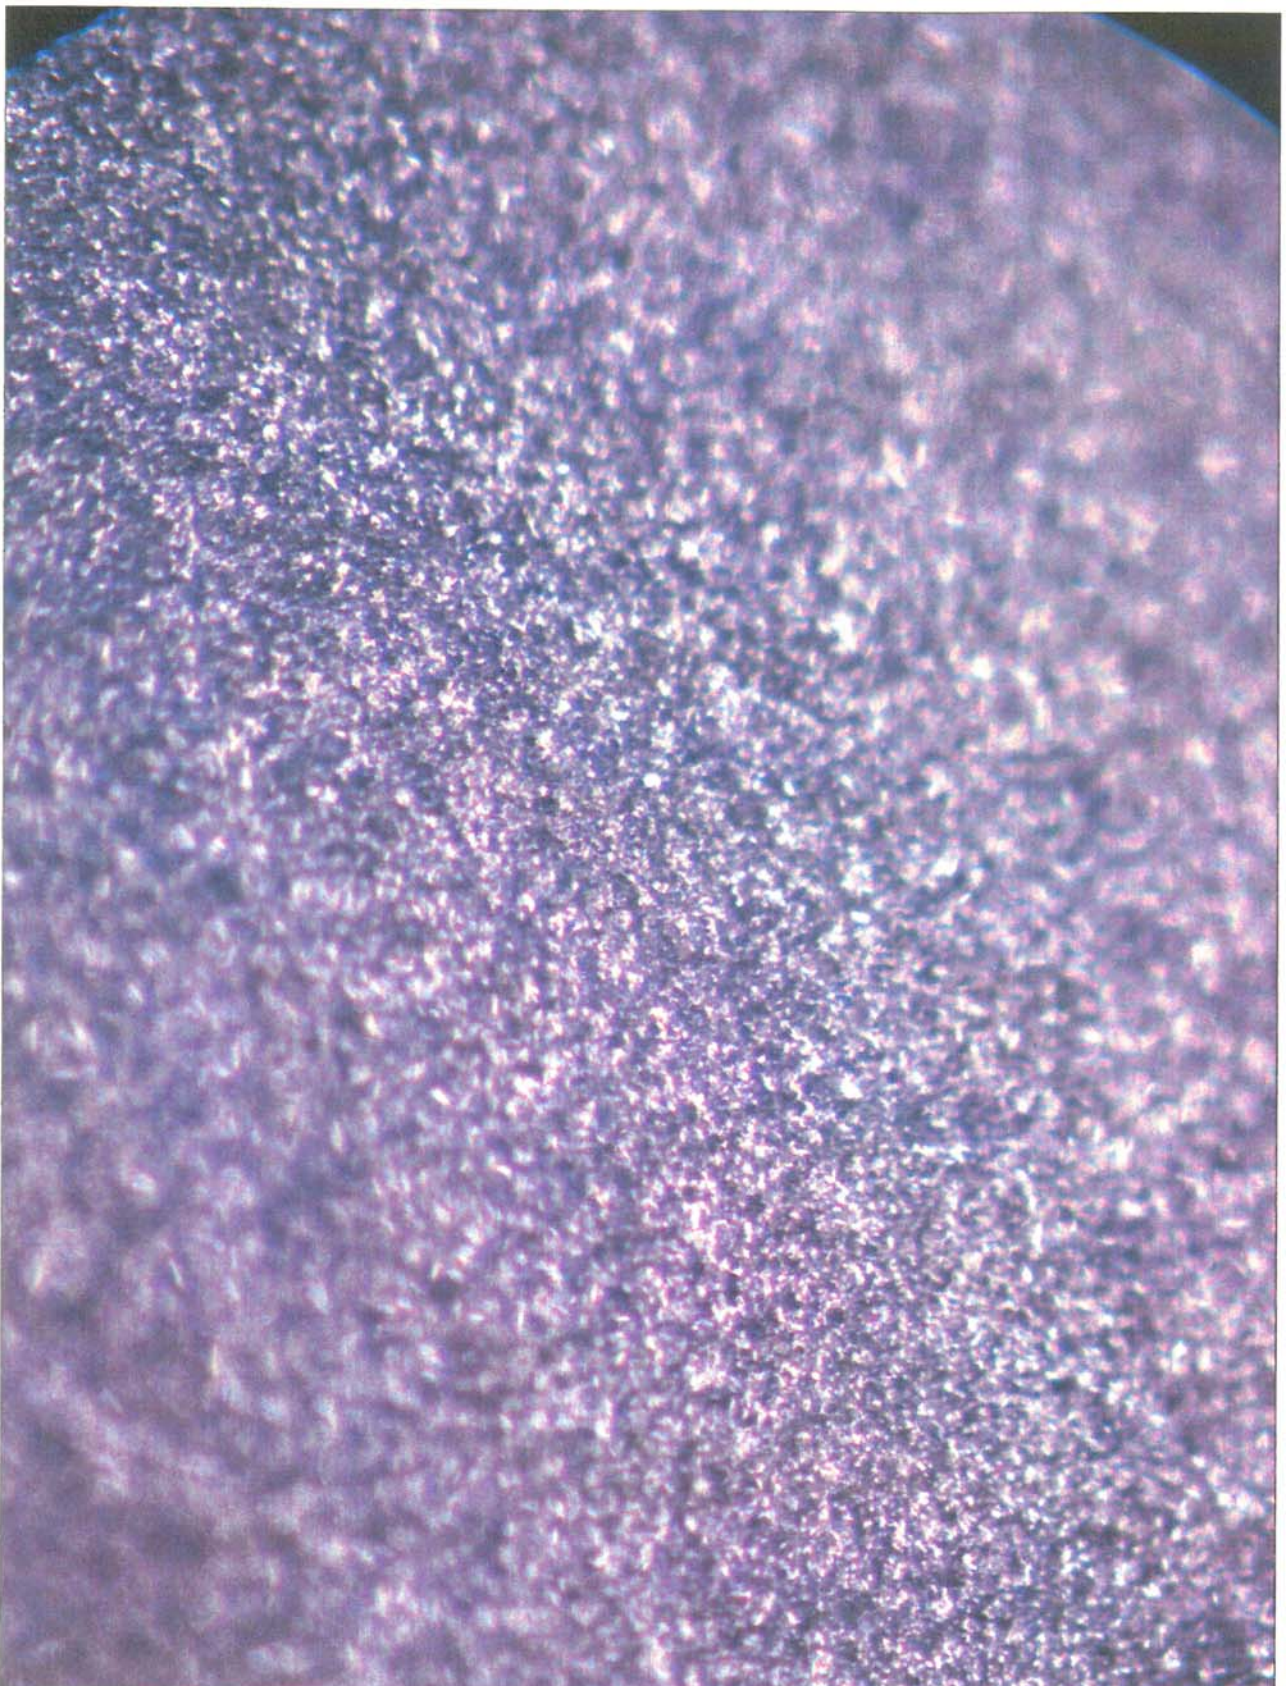
S2 at 3.0X

GM finish

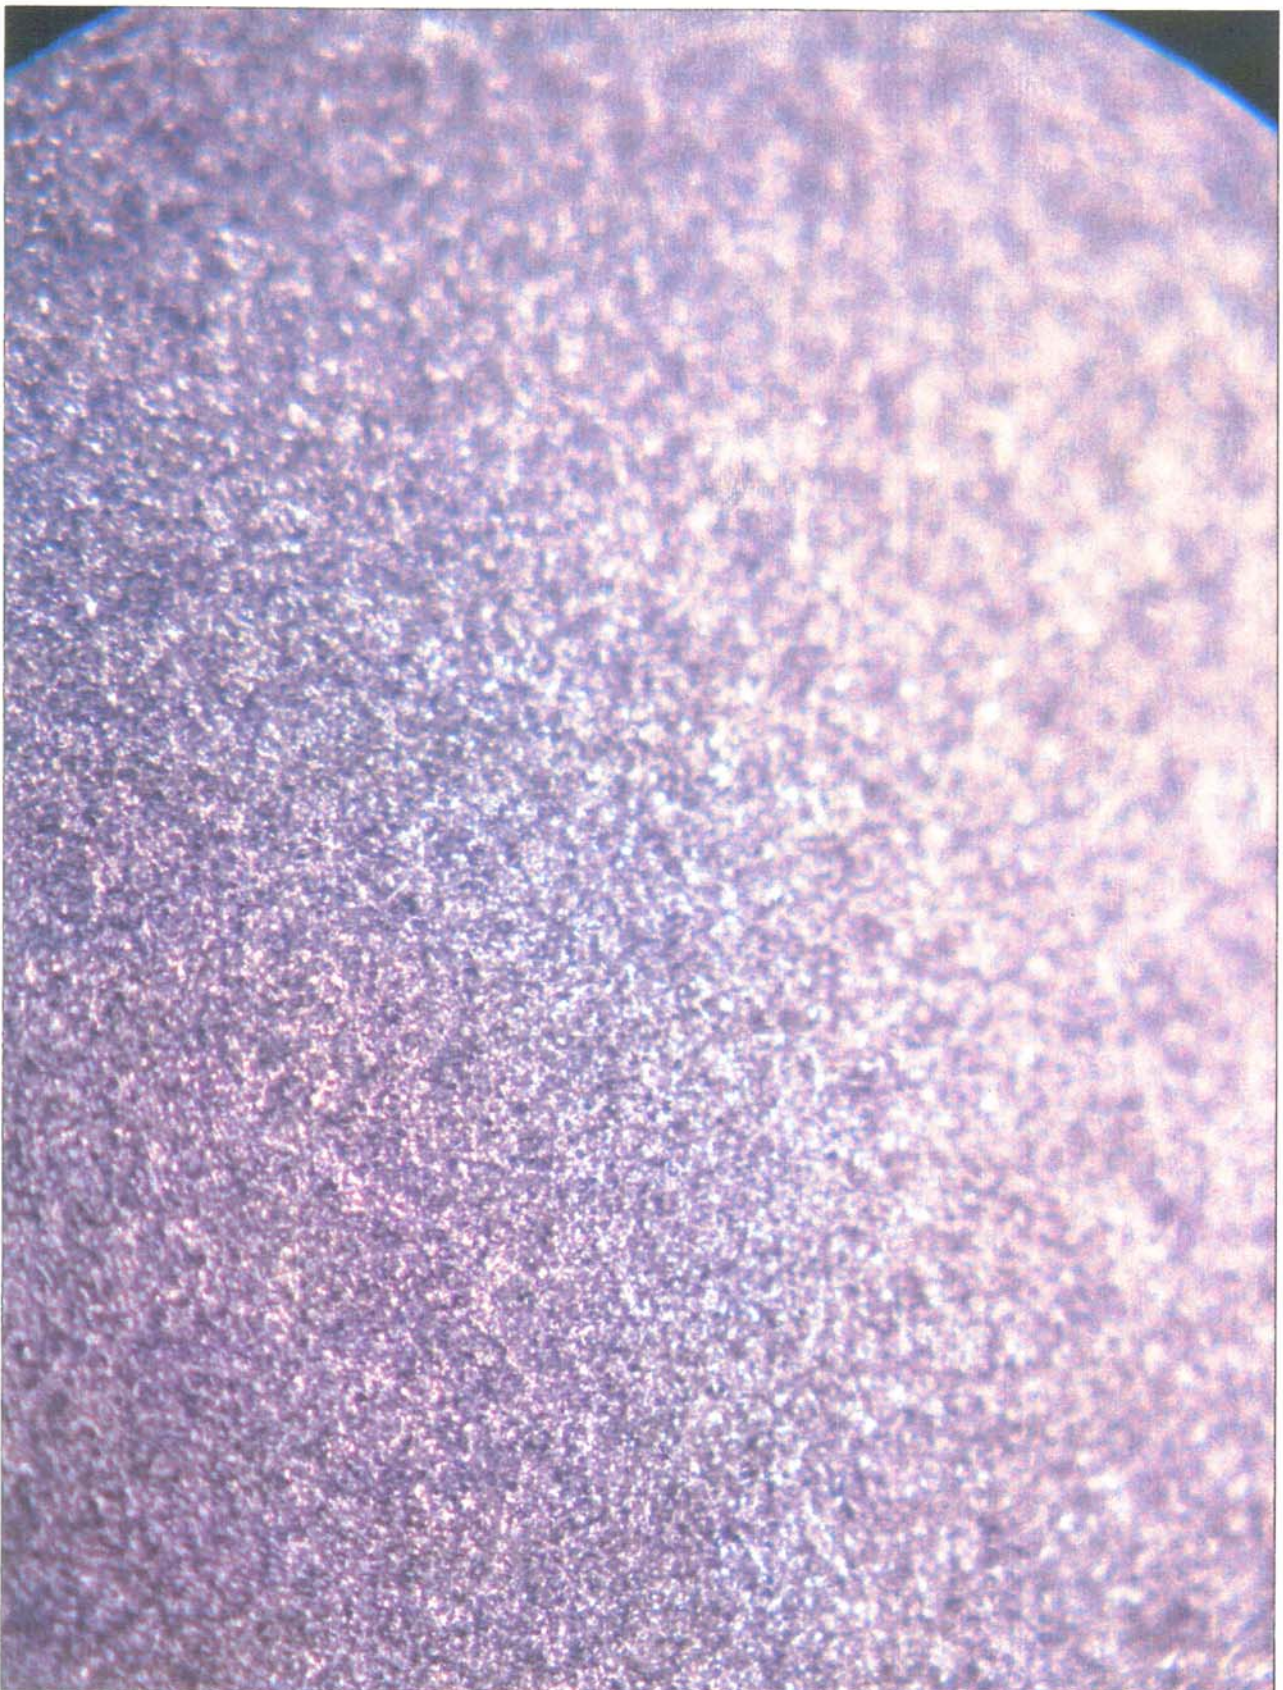
S2 at 3.0X

GM Finish

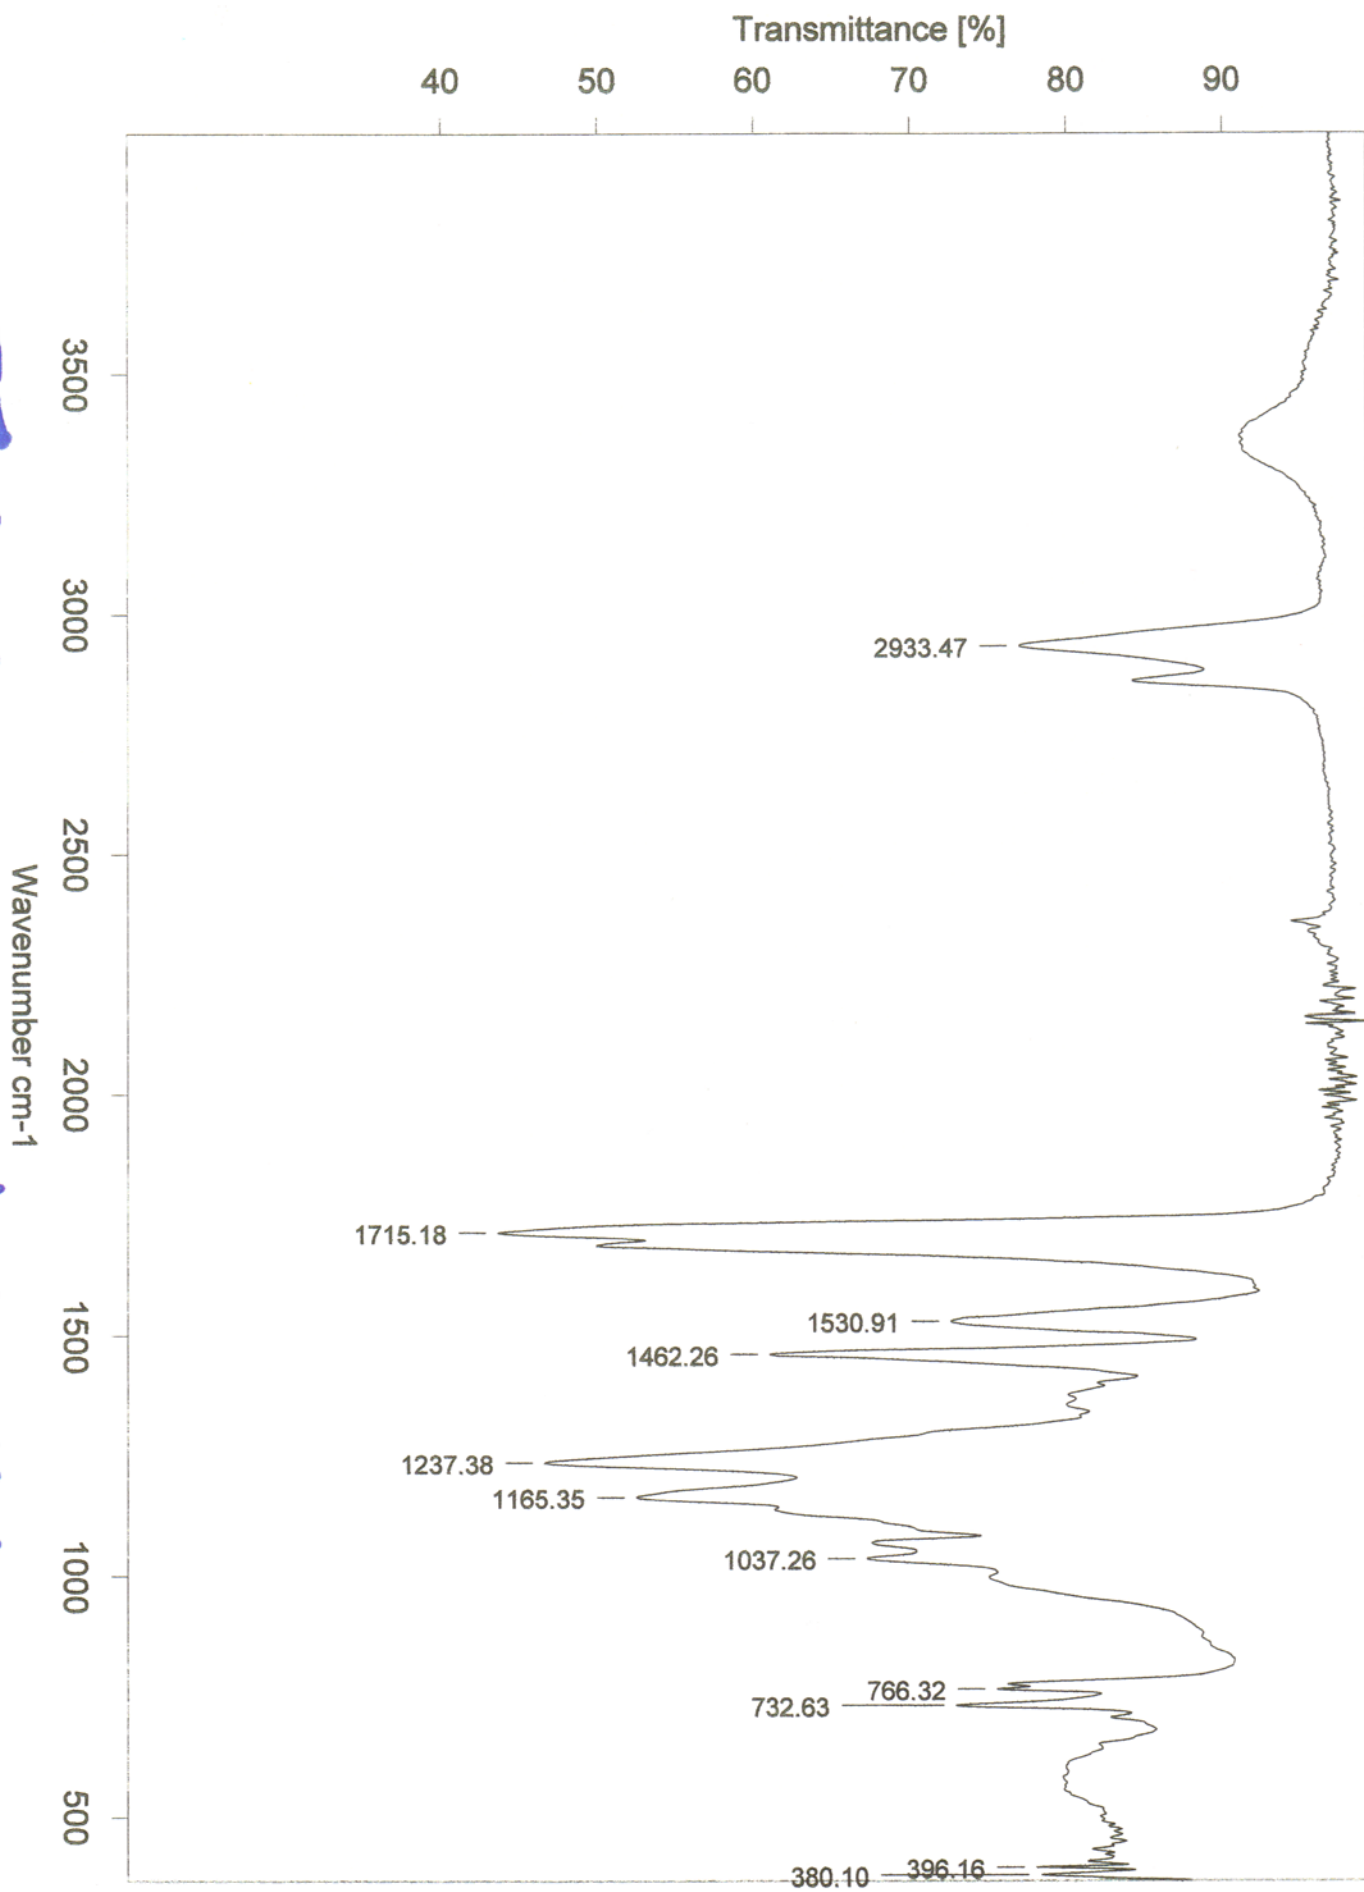
Sample 6

The FTIR spectra for the before UV exposure, sample 5 and sample 6 are the same as the spectrum obtained after UV exposure sample 7. What this means is that because no new peaks appeared in the spectrum then the polymer film was not altered by the UV exposure. That is there was no breakage of the chemical bonds in the UV film.

FTIR of Armor Coat before UV exposure

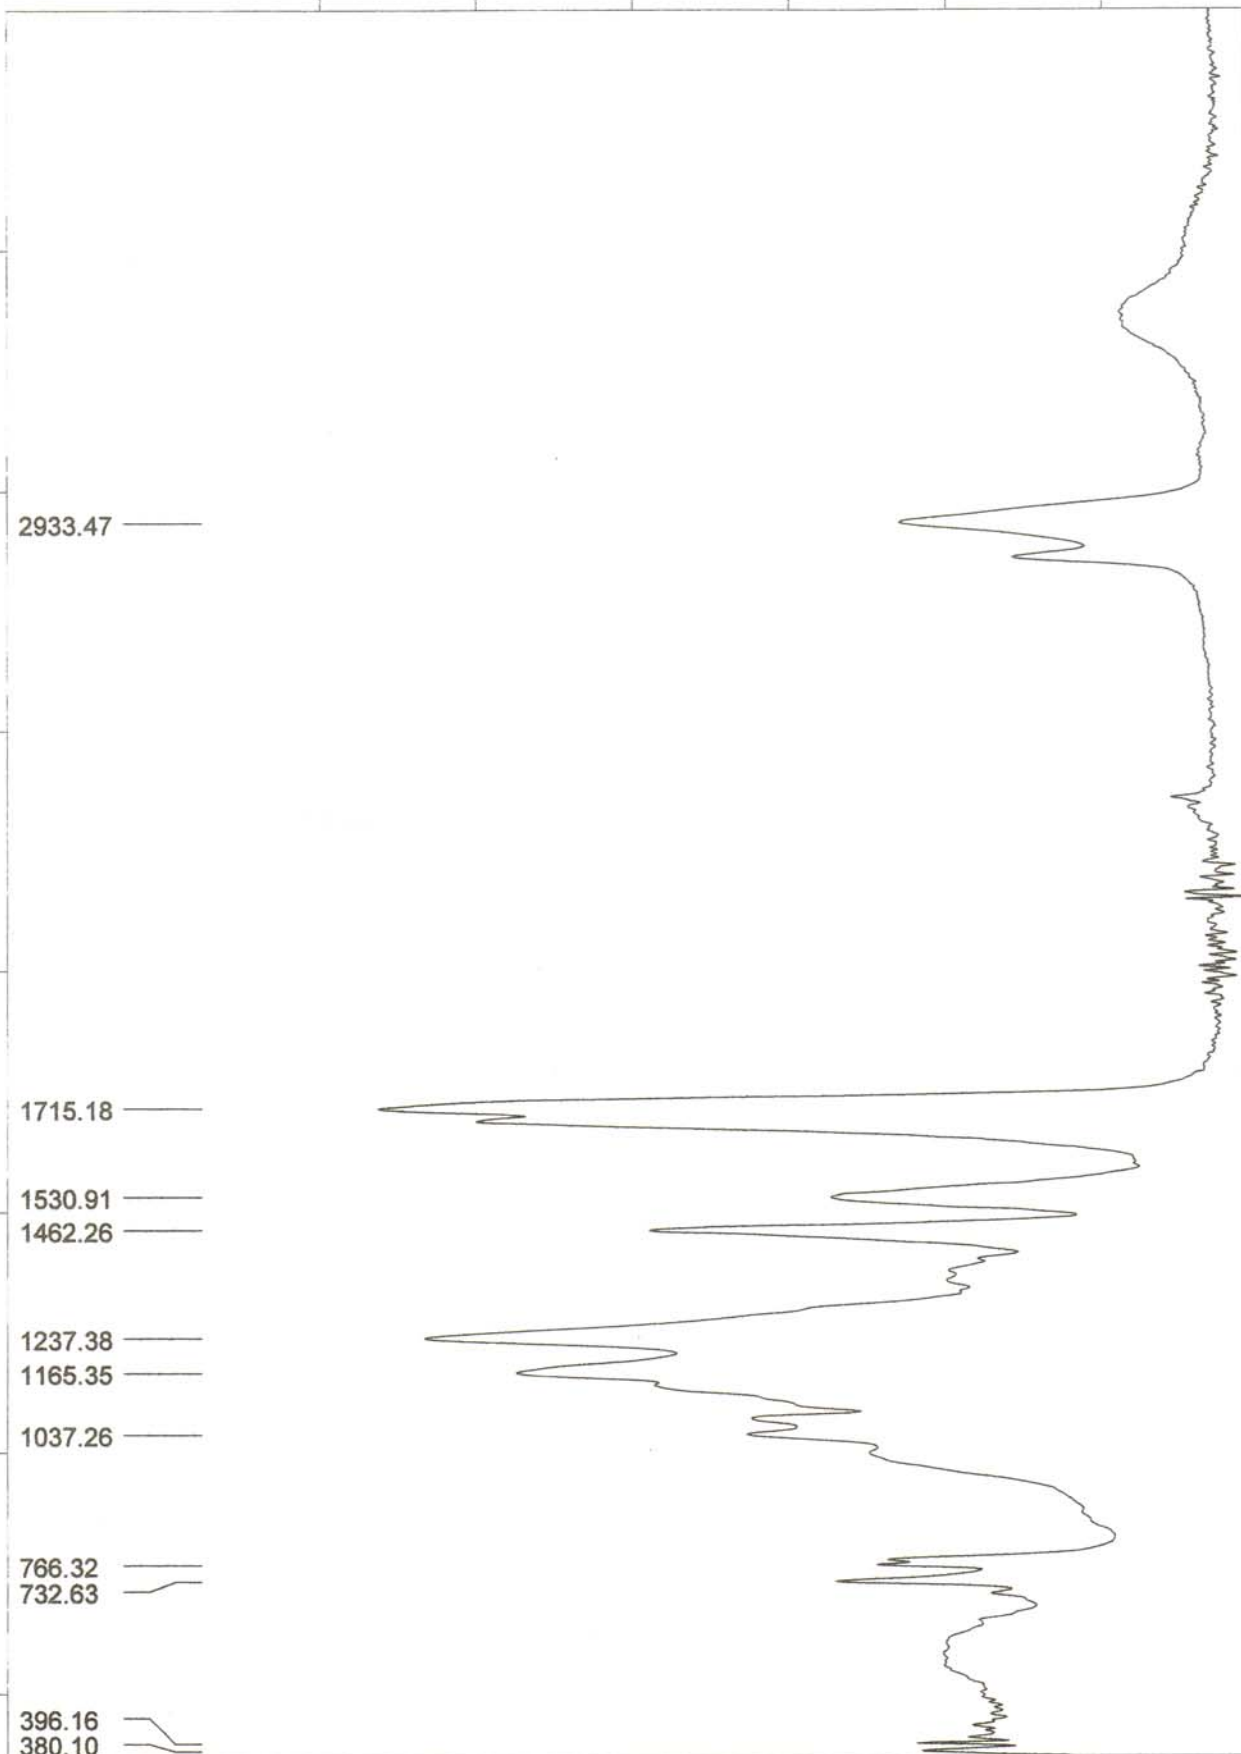
7

FTIR of ArmorCoat After UV exposure

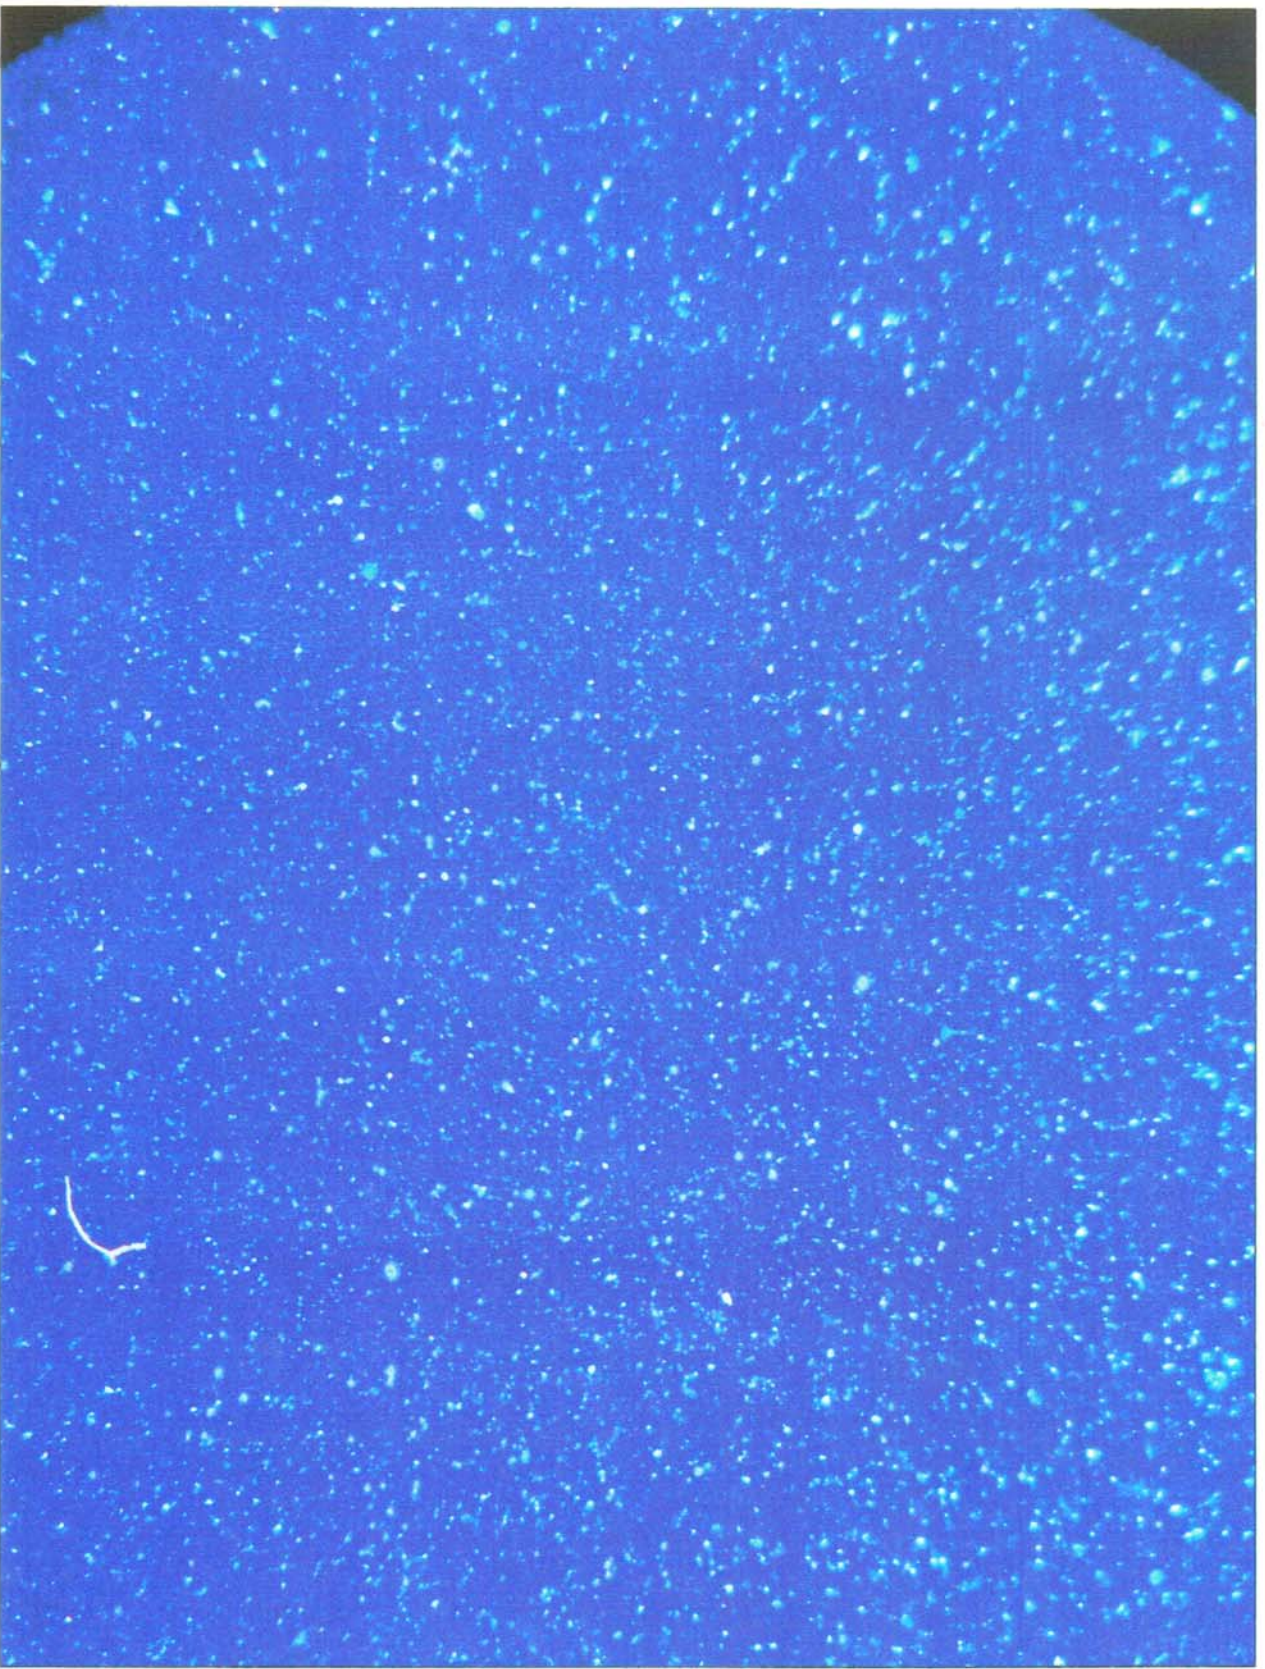
G1 at 1.0X

Micrographs of the Armor Coat finish were also taken after exposure to UV radiation. These micrographs are shown in Appendix D. The micrographs show no physical change in the polymer film as a result of exposure to UV radiation.

(35.5x) *ArmorCoat after UV exposure*

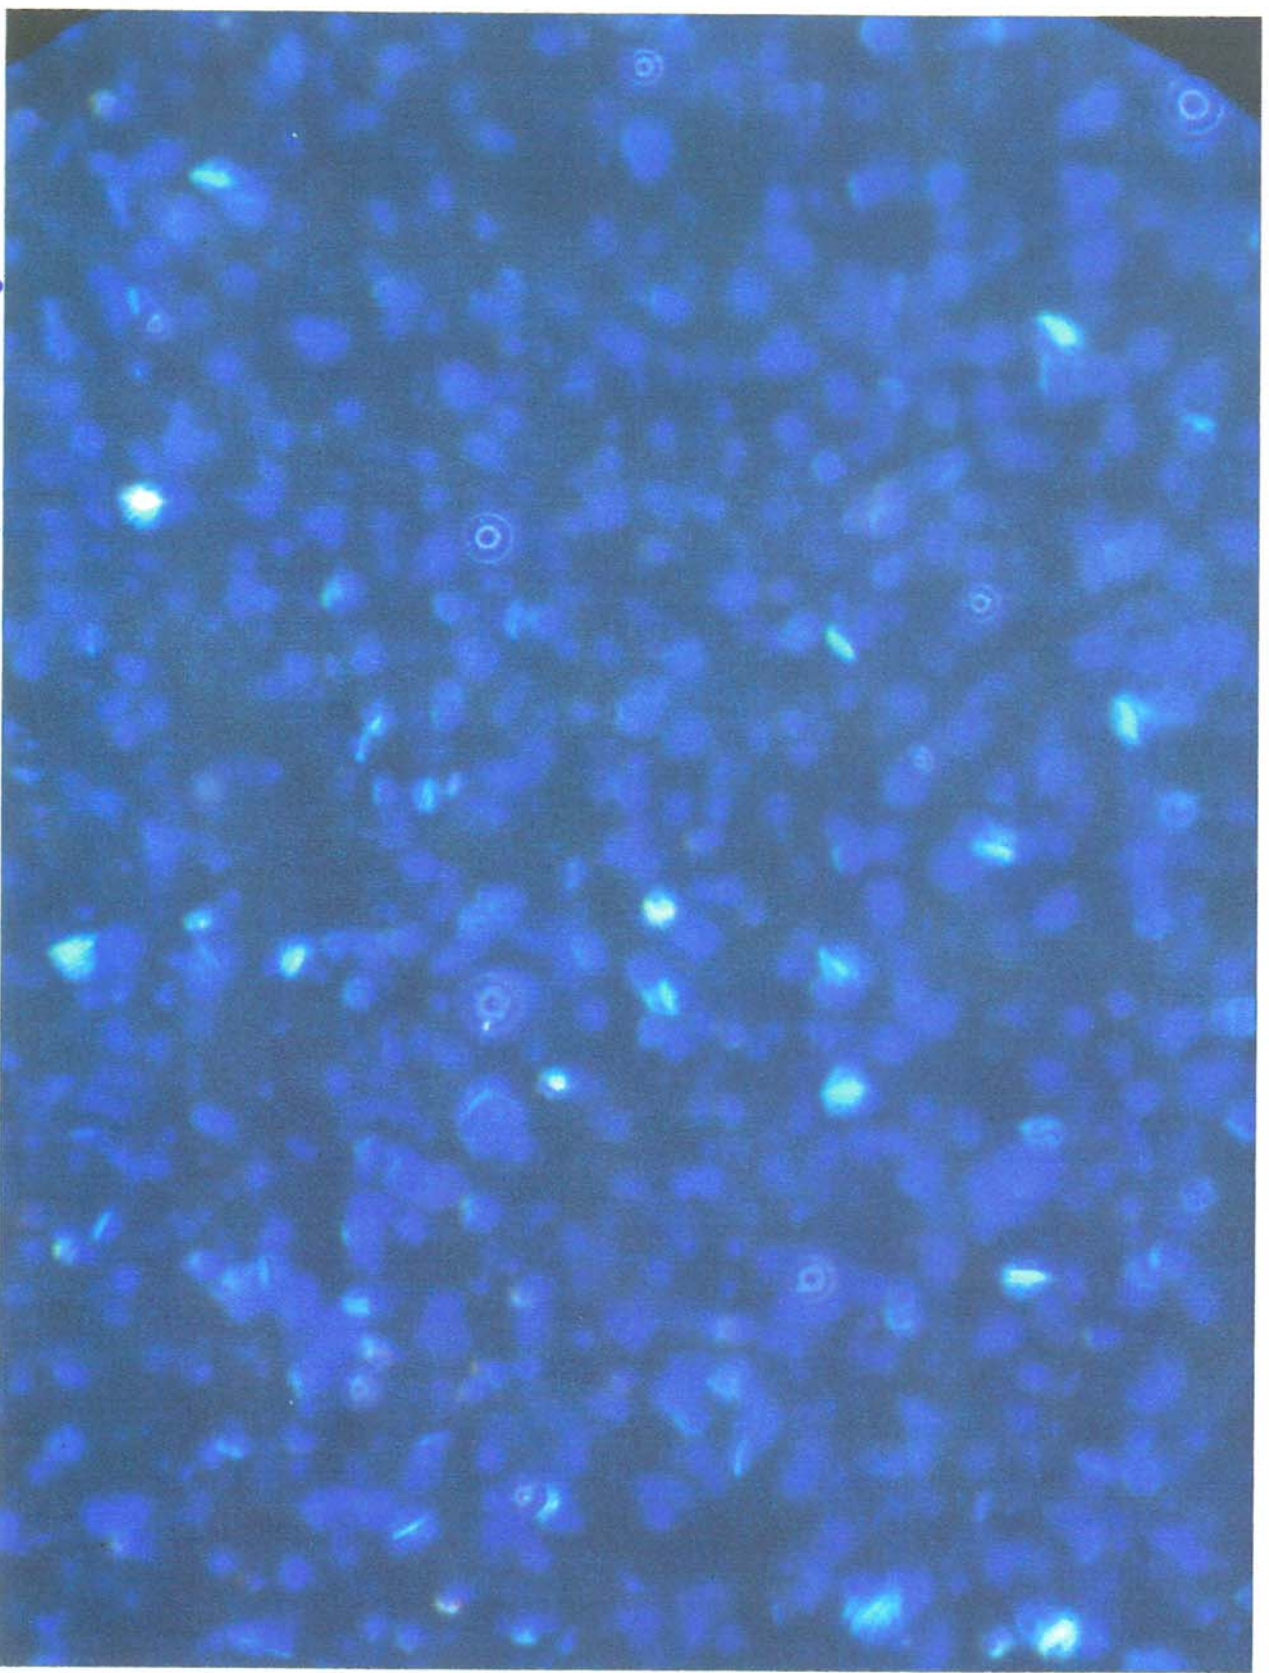
G3 at 6.3X

ArmorCoat after UV exposure
